Masonry and Roofing Assessment

Trinity United Methodist Church
Idaho Falls, Idaho

September 2015

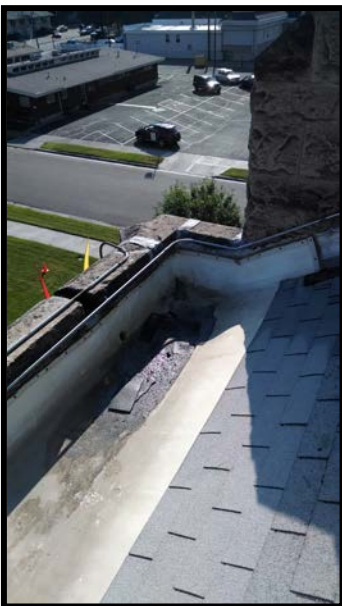
Much of the upper grout joints were deteriorated but the stone appears to be in good condition even though past improper remedial work has taken place. The joints between the capstones in many places have been sealed with a bituminous paper and roofing tar not allowing proper drainage of the stone and mortar joints. This past remedial work in return has instead caused the masonry units to retain moisture rather than properly drain.

- IV. Eliminate all immediate threats to the structural elements - **\$5,000.00**
 - a. Remove bituminous paper and synthetic sealants from all capstones

- a. Provide wick rope and breathable sealant between capstones to allow water to release from stone and mortar
- Priority #3
 - I. Replace all roofing on entire older sanctuary church building portion- **\$75,000.00**

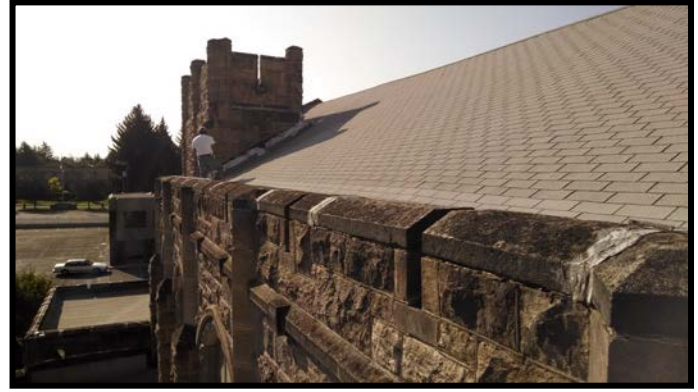
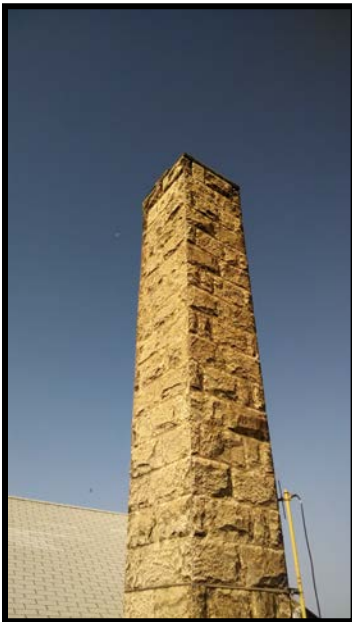
The stone work on the majority chimney appears to be in good condition as well. There appears to be a loose stones towards the top of the chimney but no other significant deterioration was noticed. Although only the stone at the top appear to be damaged more stone and mortar joints may be deteriorated further down and are not noticeable. Also the current chimney is not braced in any fashion. Current code would require for this type of construction to be braced in order to prevent collapse during a seismic event.
